To:	Martin Dancy	From:	Geosciences Ltd
CC:	Tony Hayman	Reference:	Mem-1676/SQI/Nov21
Date:	16 November 2021		
Subject:	<b>Soil Quality Investigation of Lot 2 of Subdivision of 404-424 Whitmore Road, Takatu.</b>

**Figure 2 - Sample Location Plan**

**Proposed Lot 2, 404-424 Whitmore Road, Takatu**

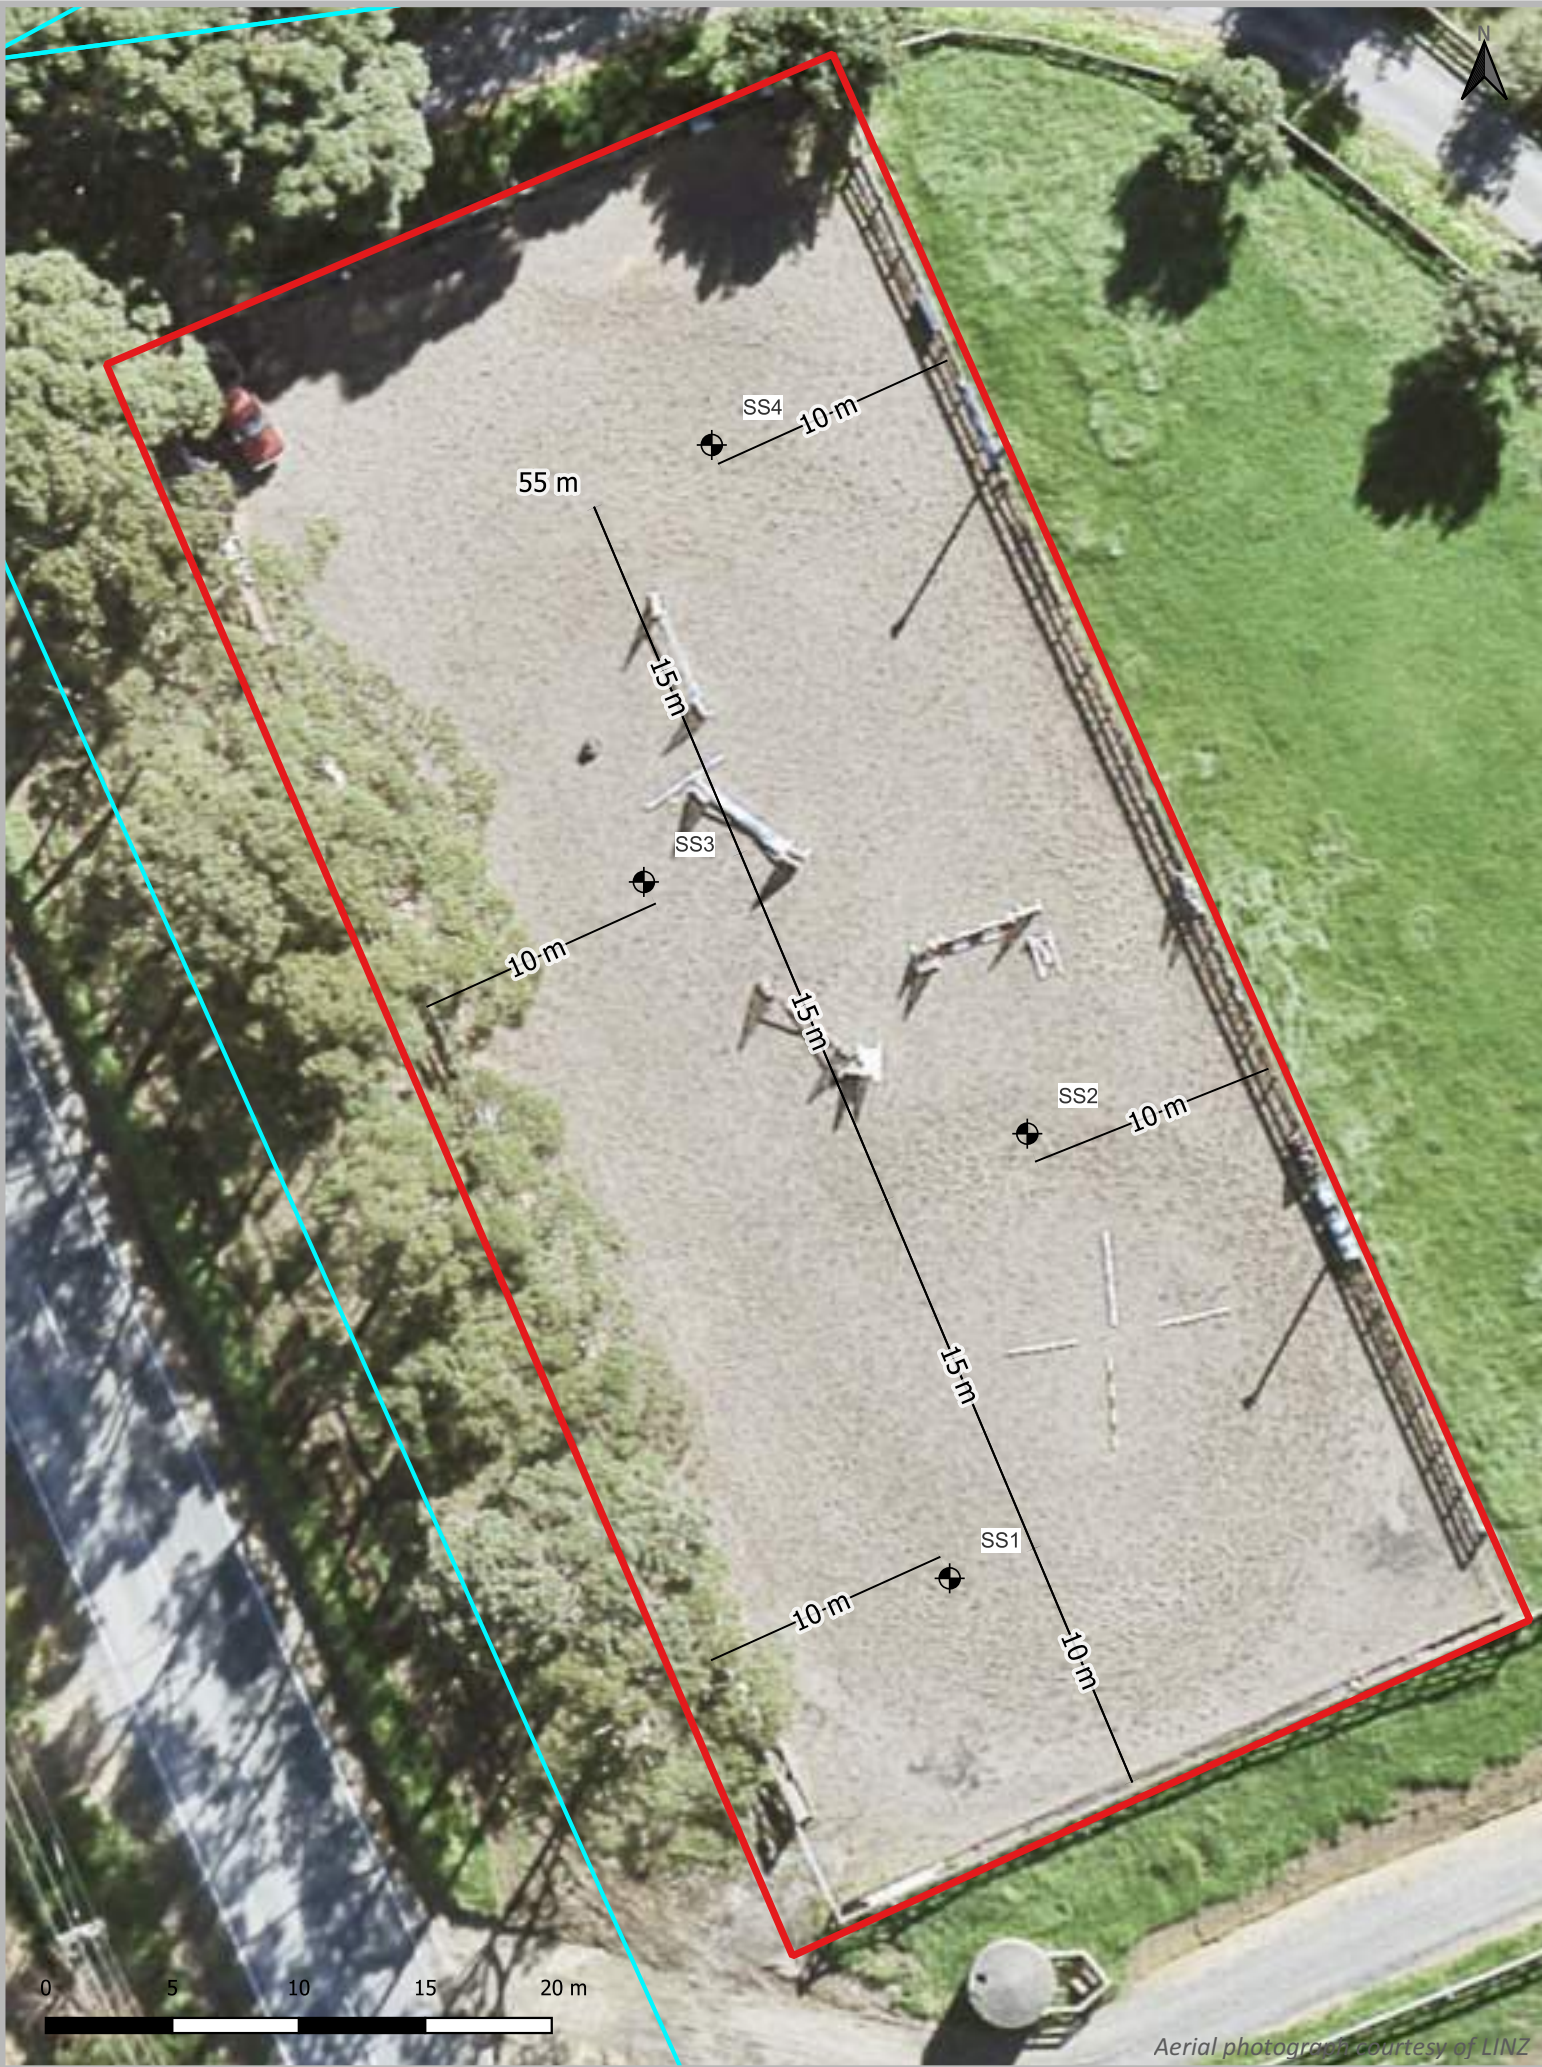
Soil sample locations are indicated on Figure 2.

A summary of the analytical results is provided in Table 1 below. Copies of the laboratory transcripts are appended to this memorandum, while indicative soil sample locations are shown in Figure 2.
